# Portage Creek Sediment Remediation Project Kalamazoo, Michigan

Pre-Sediment Removal Structure Feature Assessment  
Removal Areas SA1-A, SA1-B and SA1-C

**FLEIS & VANDENBRINK  
ENGINEERING, INC.**

F&V Project Number: 809930  
May, 2013 (Updated June, 2013)

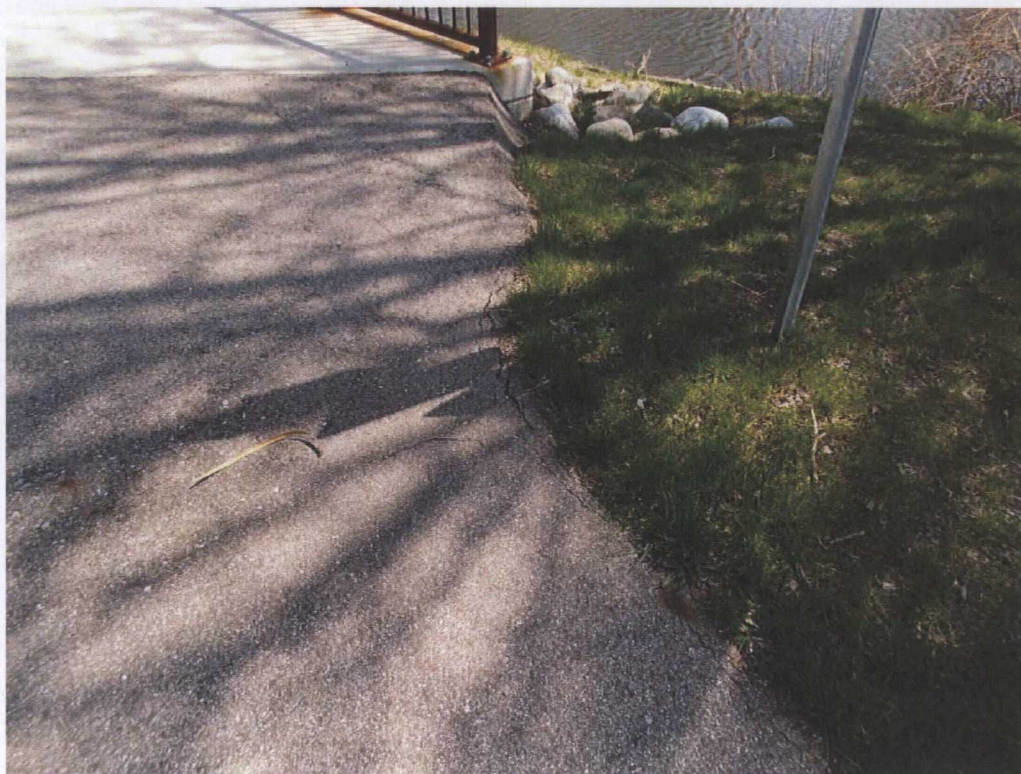
- Brush growth is encroaching on the southeast quadrant of the structure.
- The asphalt/concrete joint on the west approach is opening slightly. The asphalt has an isolated area of edge cracking in the southwest.

Edge cracking in the southwest asphalt approach area

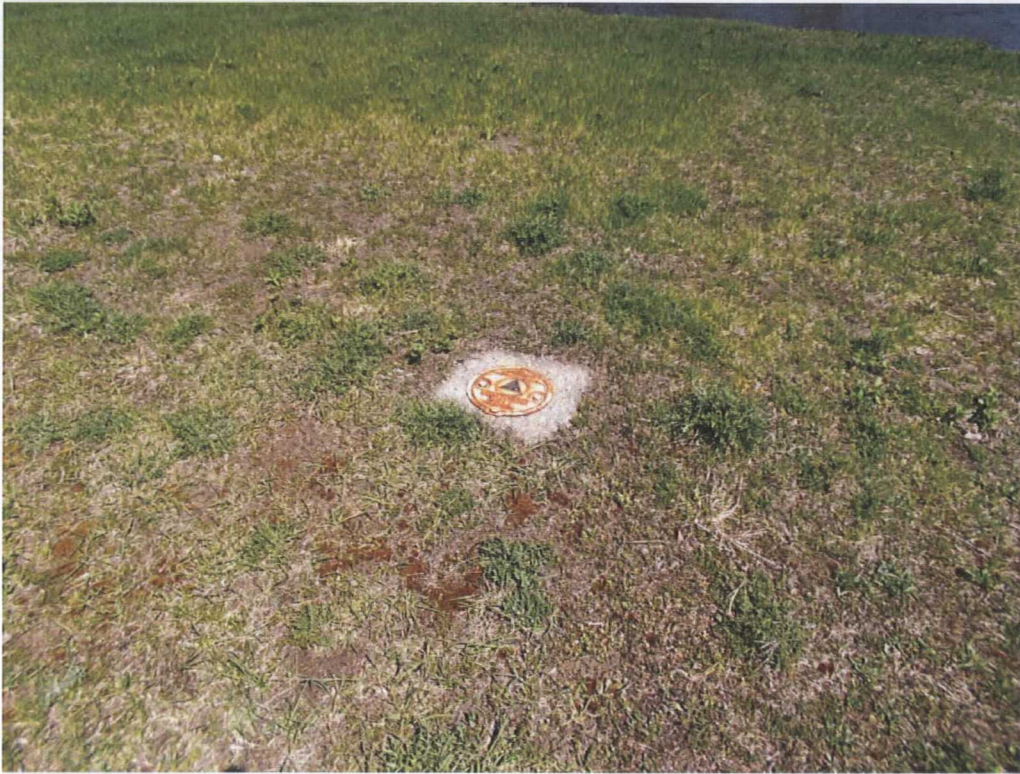
Monitoring well in the northwest

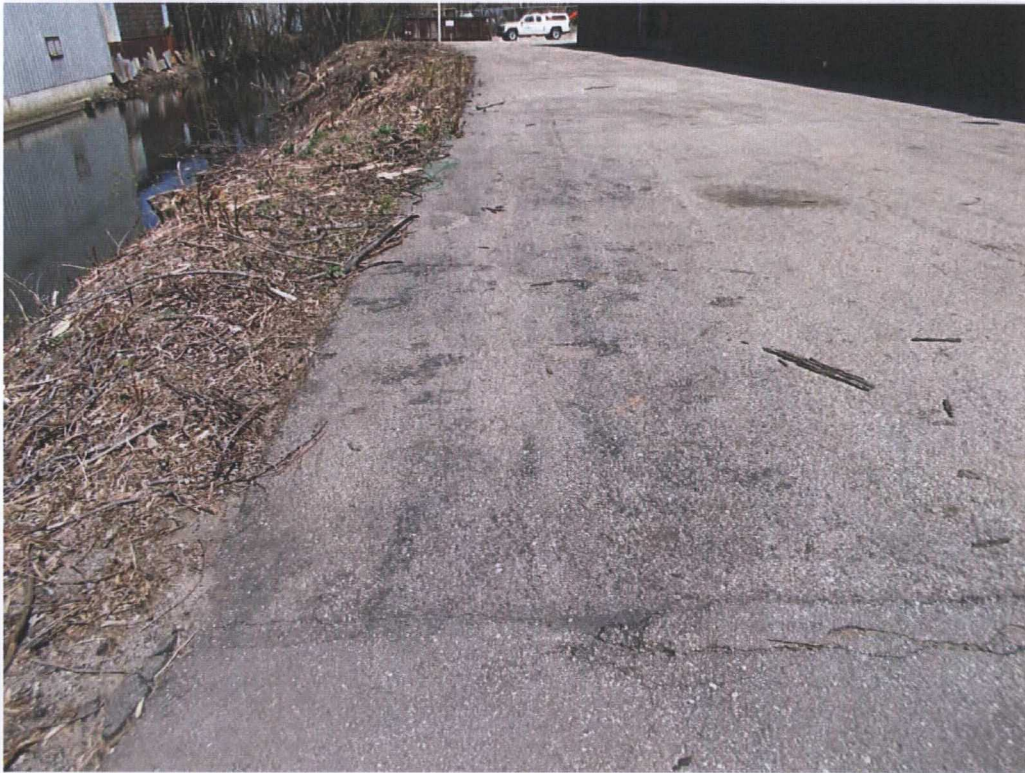
View of pavement area looking north toward SA1-B

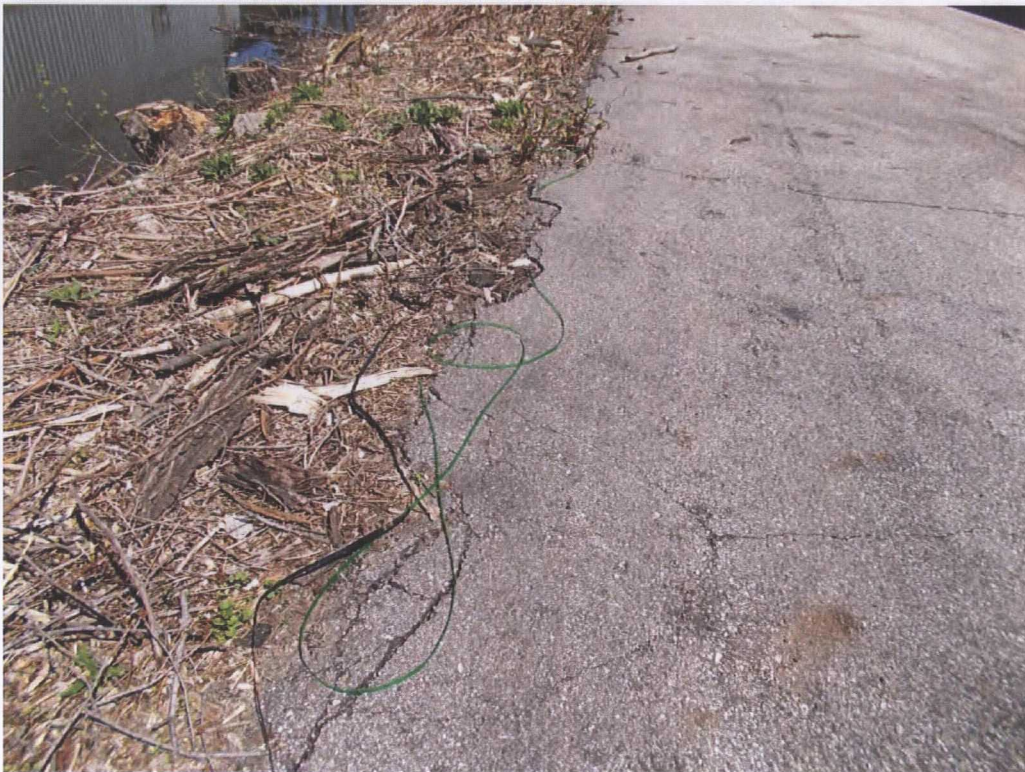
- The asphalt pavement is in fair to poor condition with cracking throughout, some of which has vegetation growth.
- Severe edge cracking and spalling was noted.
- Several areas of settlement and alligator cracking were noted.
- There is a concrete bumper at a commercial dumpster near the north end of the pavement area.

Edge cracking and spalling

- Repair or replace damaged areas of pavement as required.

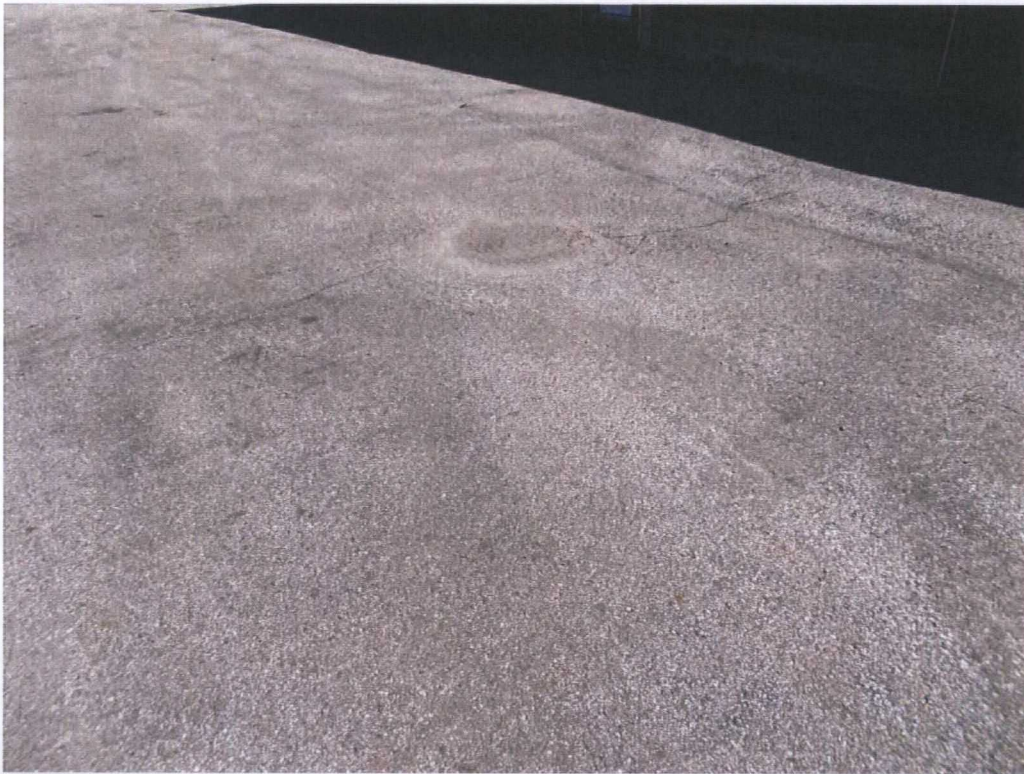
Area of severe settlement

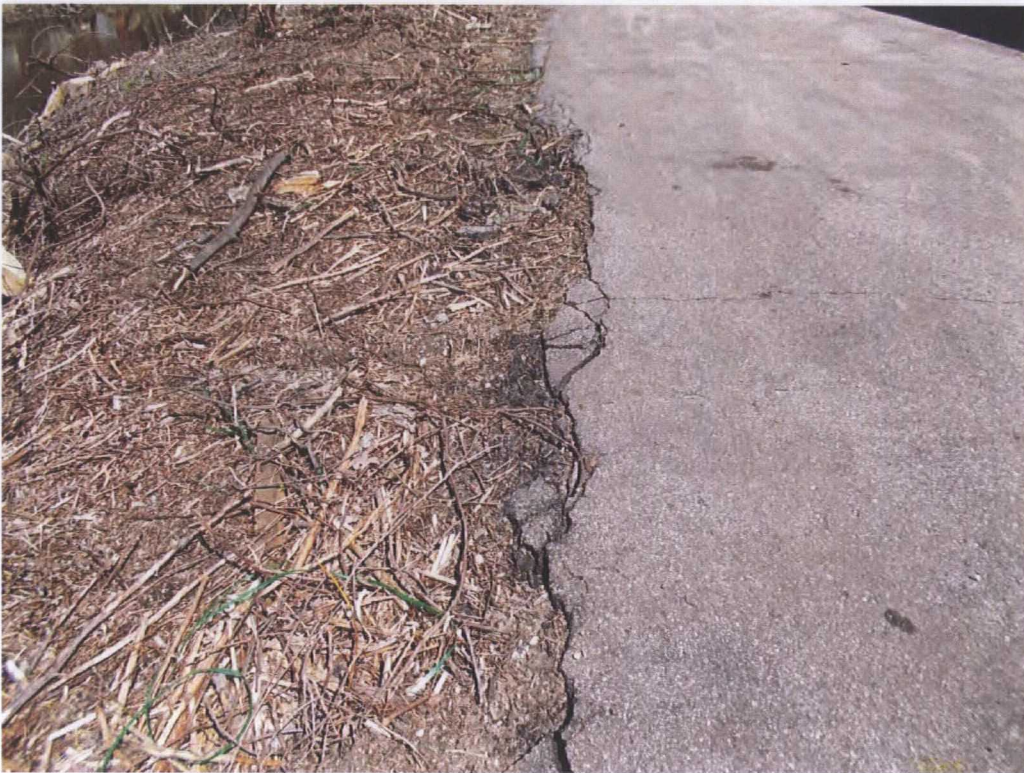
Severe edge cracking and spalling

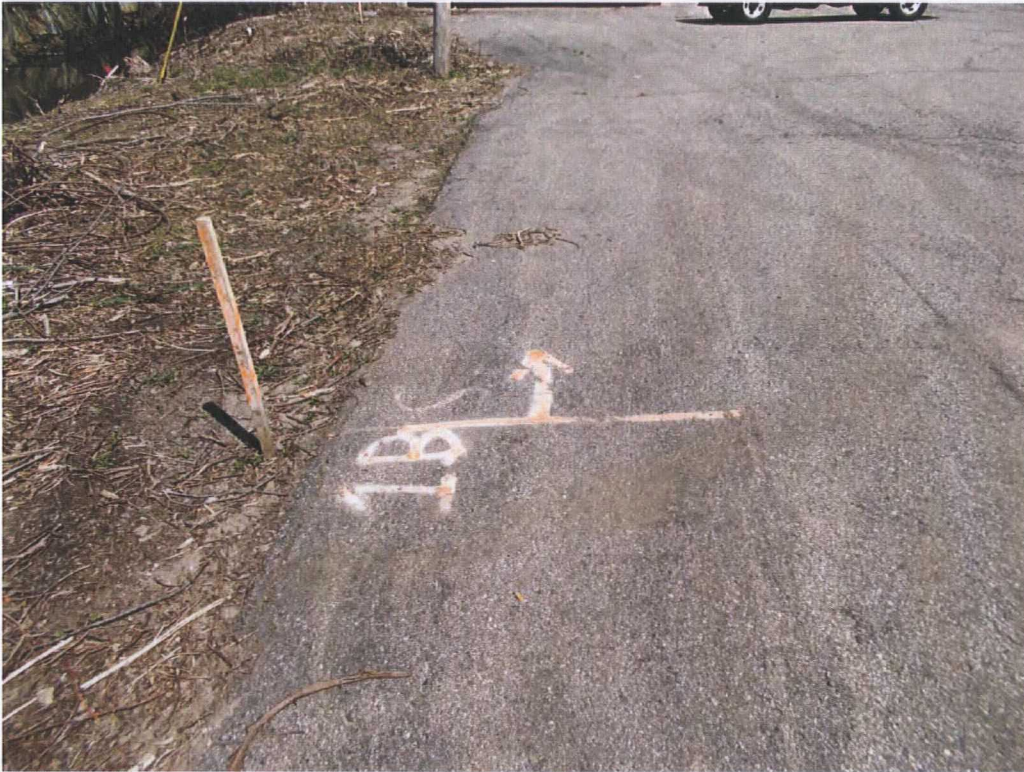
Pavement at south end of SA1-B

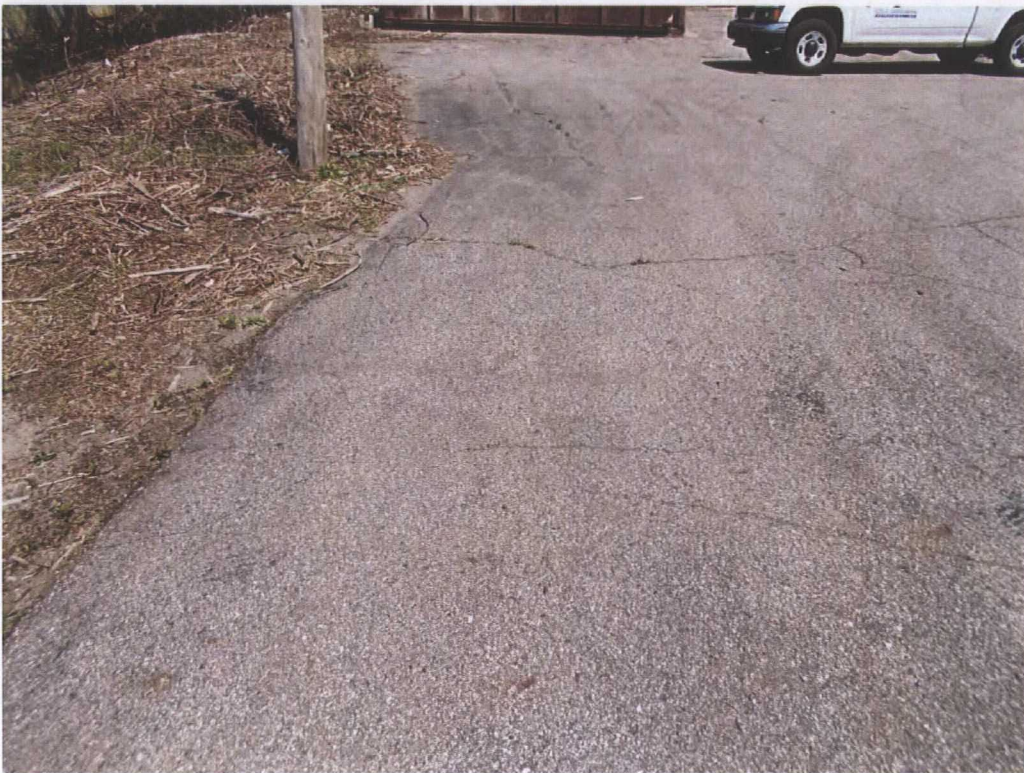
Random cracking in pavement

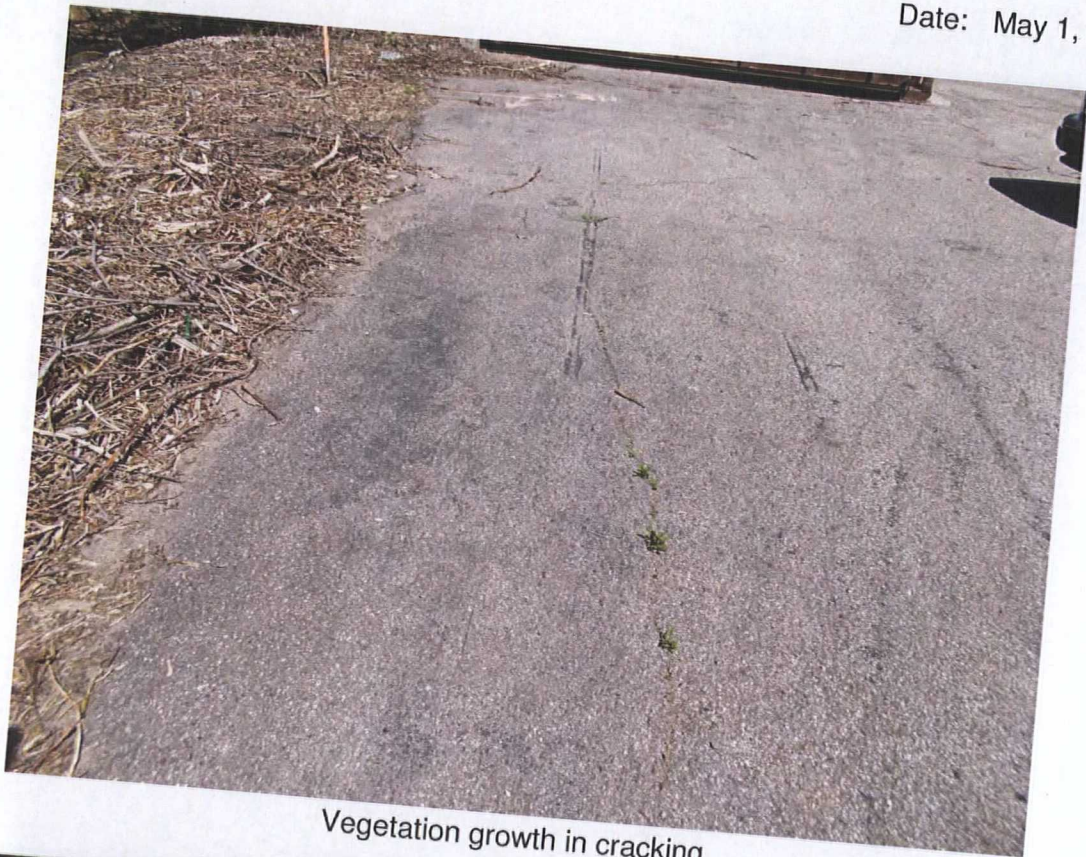
Vegetation growth in cracking

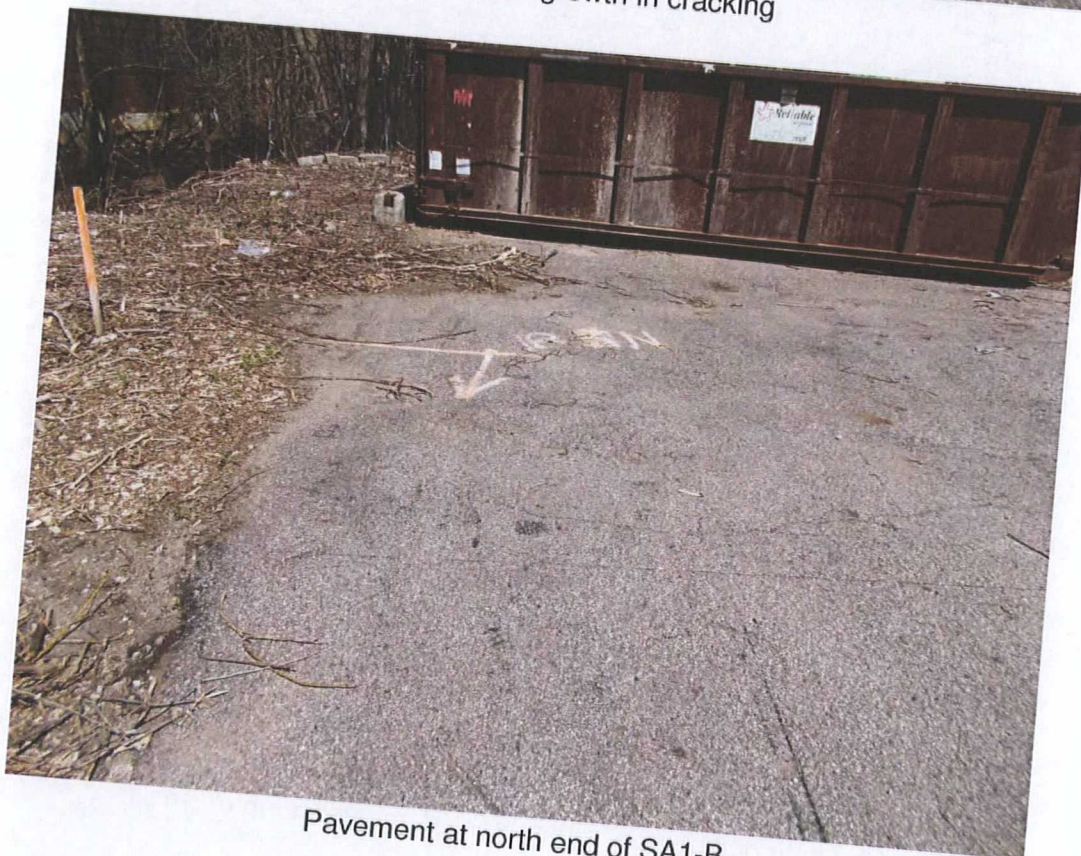
Pavement at north end of SA1-B

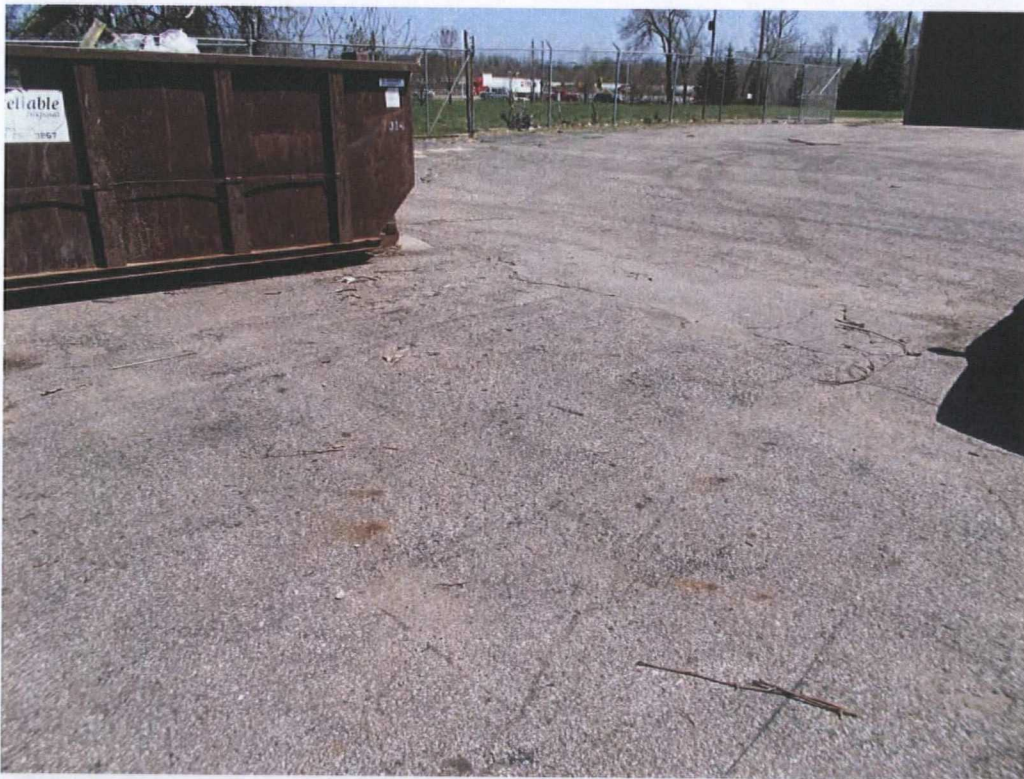
Random cracking in pavement

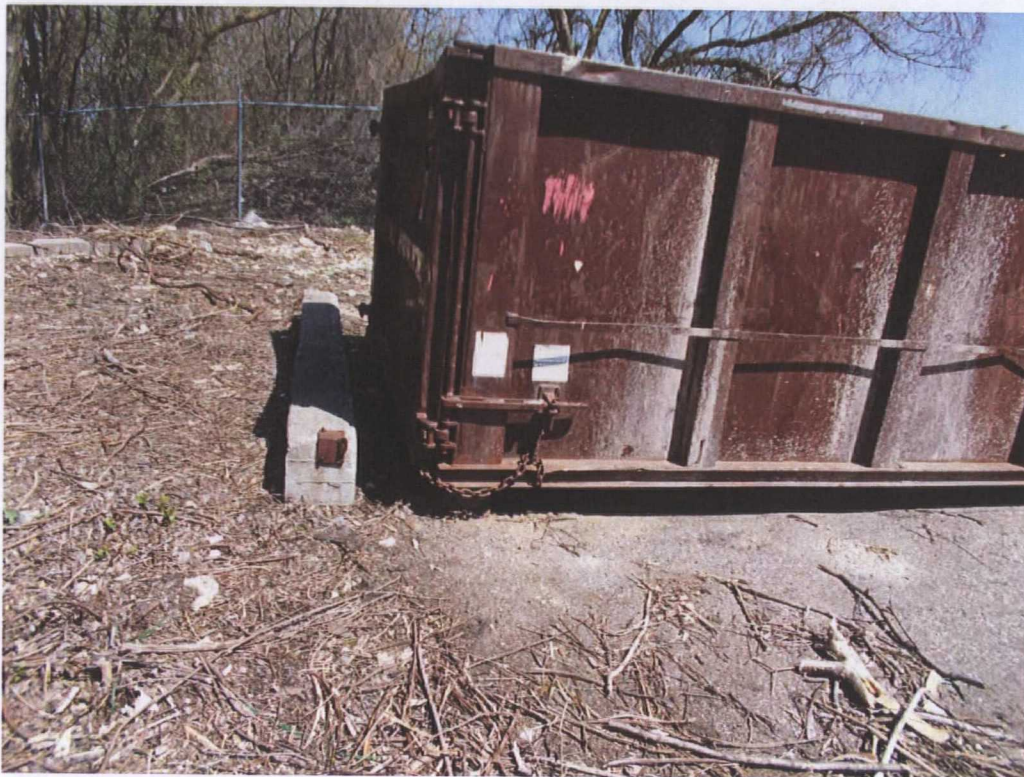
Concrete bumper and commercial dumpster north of SA1-B

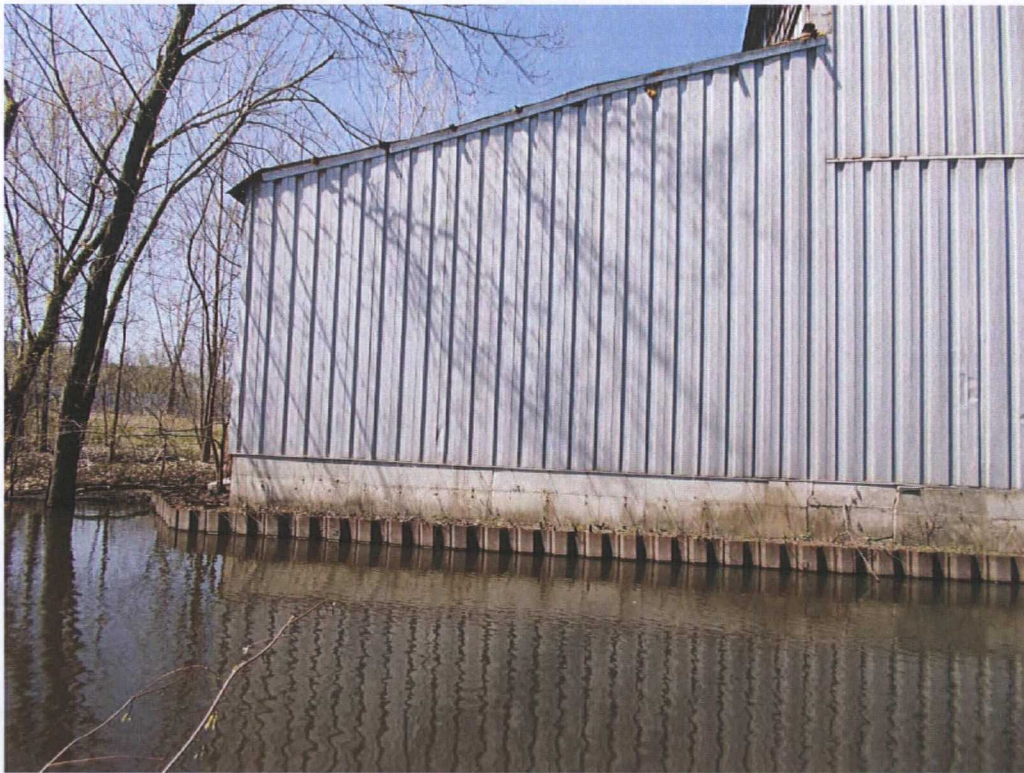
View of south end of structure from east bank

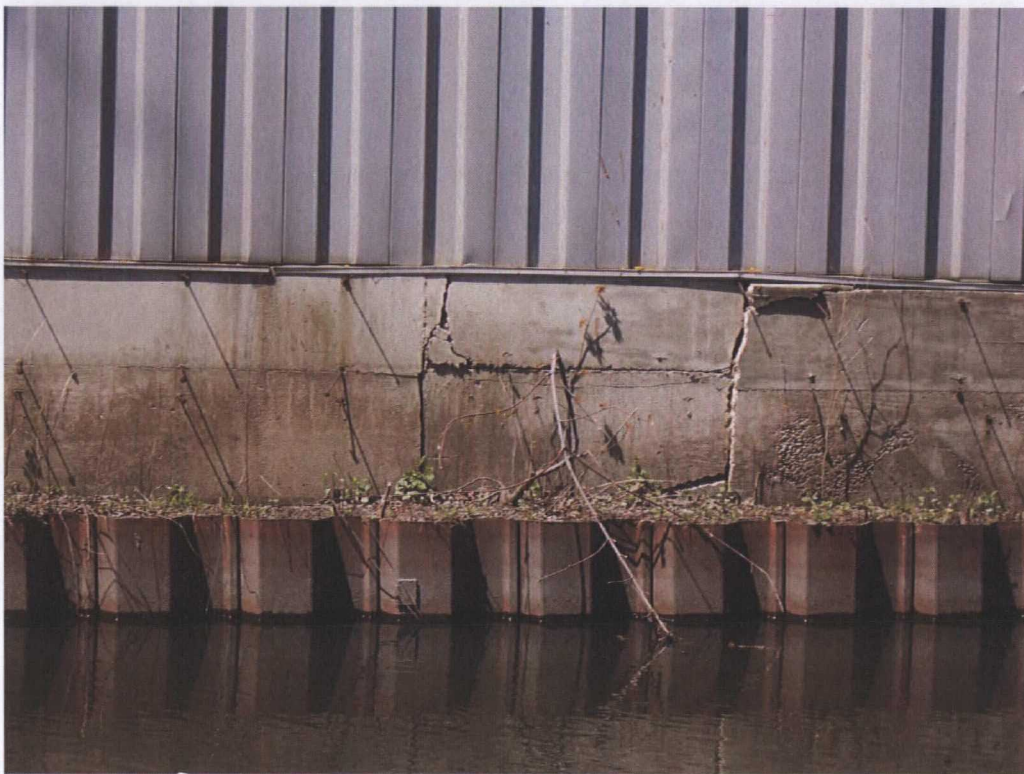
- The channel is 3.5-4.0 feet below the top of sheet pile.
- The concrete foundation wall has moderate honeycombing at pour joints. There is an area of critical vertical cracking with a 2" offset in the wall near the change in roof lines. There is a moderate vertical crack near the north end of the sheet pile.

View of area of critical cracking in concrete foundation from east bank

- Due to the limited sediment removal depth (approximately 1 foot), it should be possible to remove sediment against the sheet pile wall without disturbing it.
- It is recommended that the bank north of the sheet pile wall be left intact to avoid impacting the unknown foundation for the northern section of the building. If the bank cannot be left in place, a longitudinal cofferdam is recommended along the building with a minimum clearance of approximately 4 feet.
- Avoid excavation within 3-4 feet of the exposed concrete footing to prevent undermining or other disturbance.

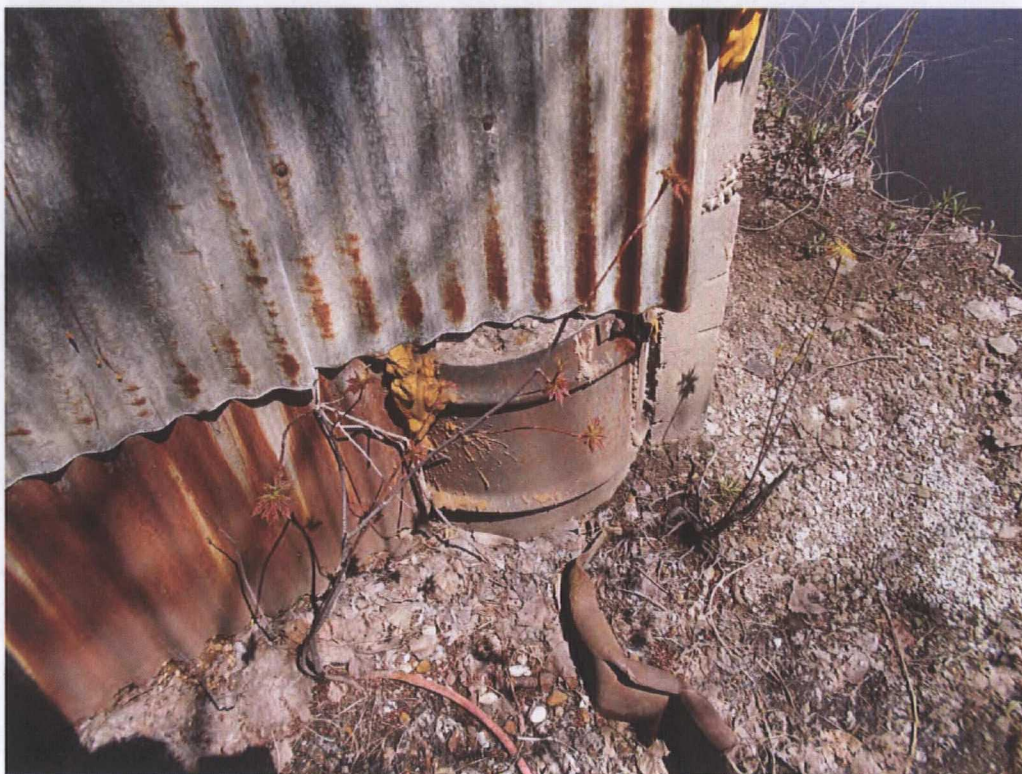
Suspected steel drum filled with concrete in southeast foundation

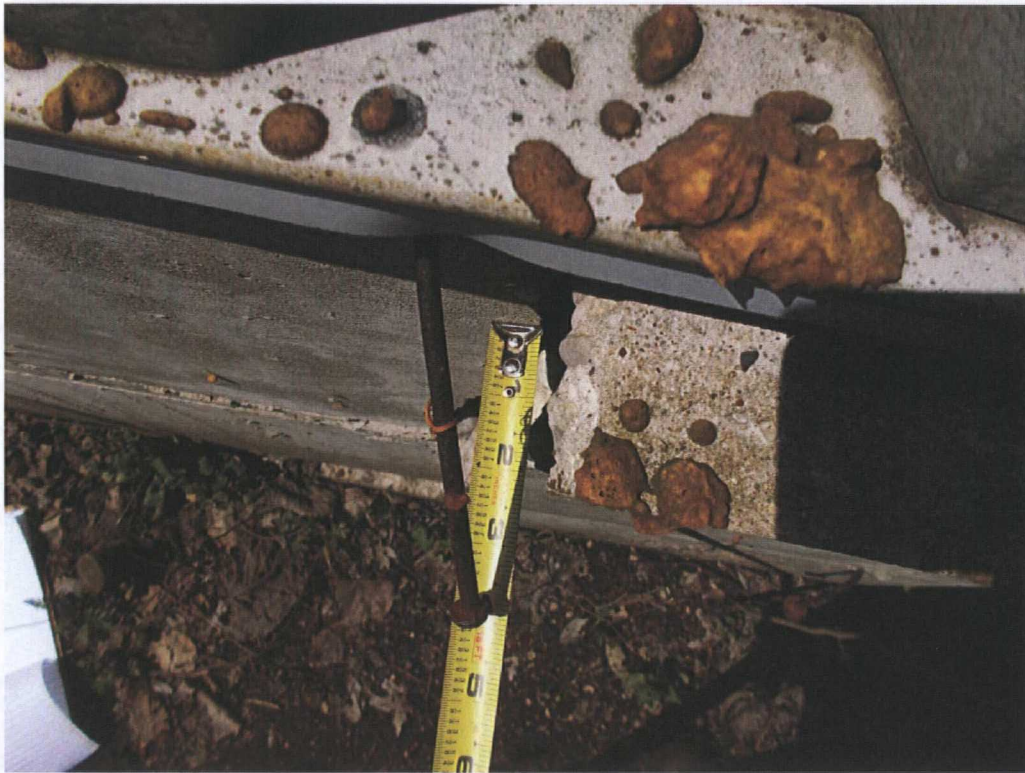
View of offset at critical cracking looking down

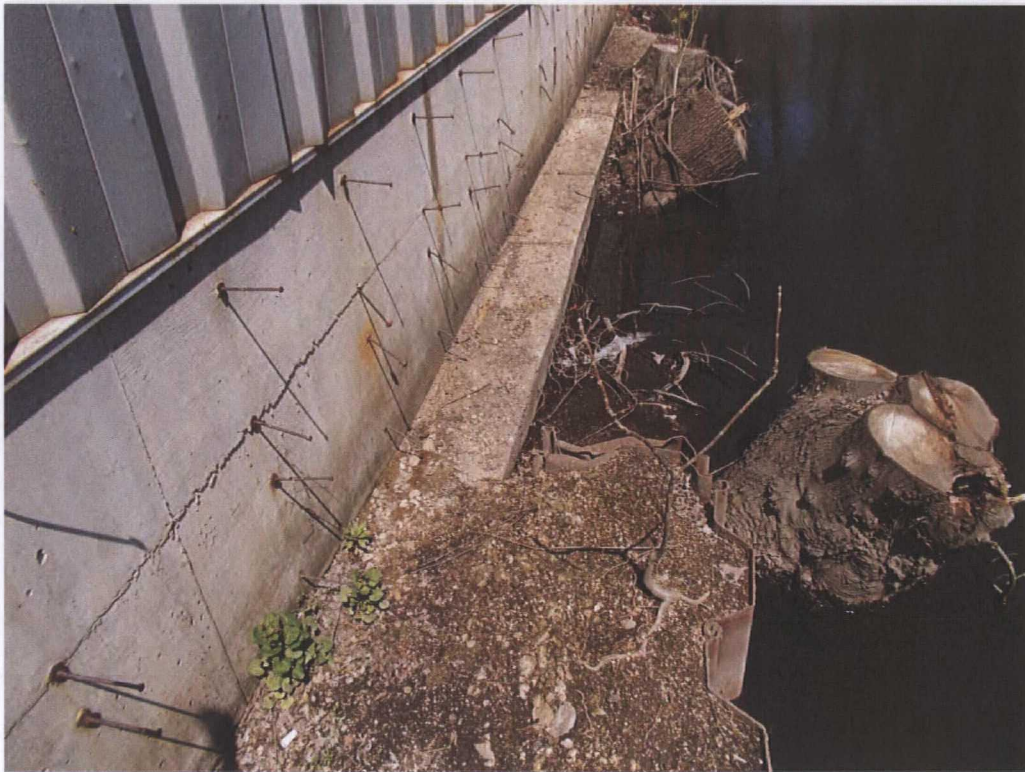
- The bank north of the sheet pile is mostly intact due to a series of large trees and stumps. The footing of the northern end of the concrete foundation wall is exposed approximately 8-12 inches.

Exposed footing at north end of southern section of building

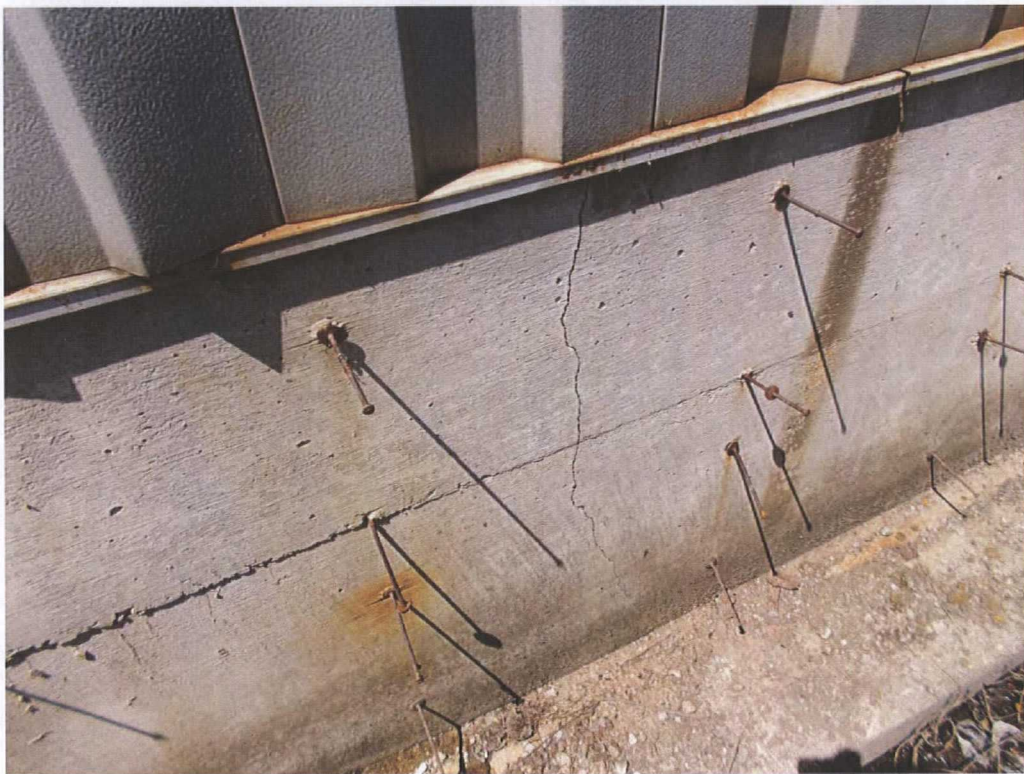
Moderate vertical cracking near north end of sheet pile

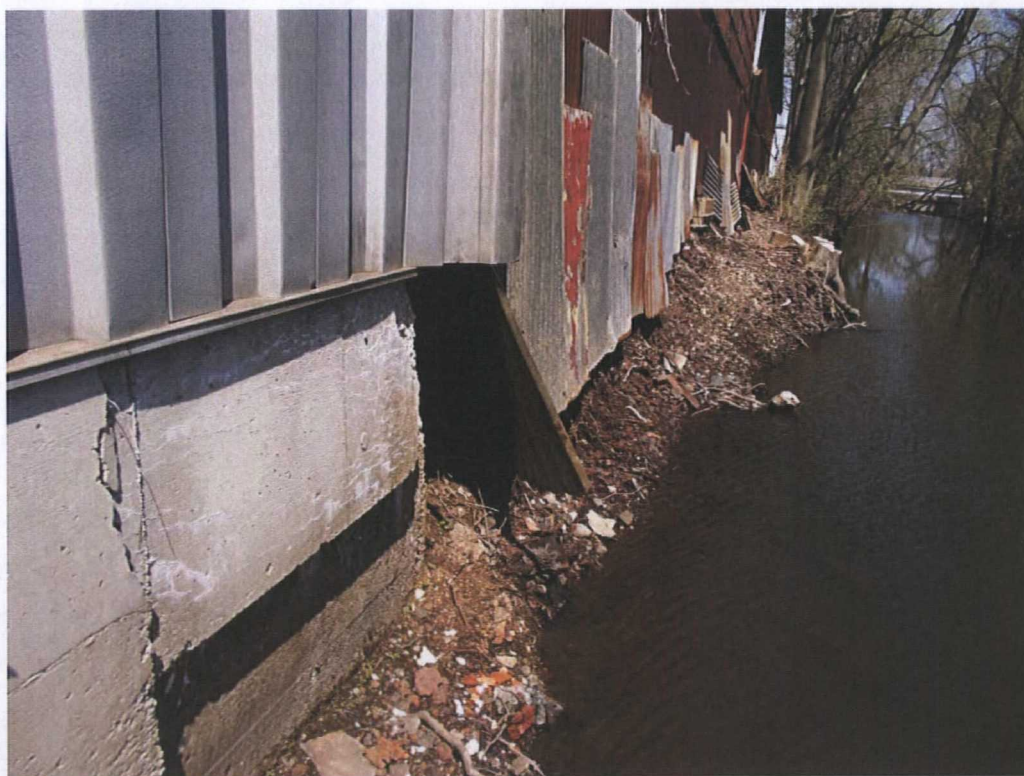
- The siding on the southern portion is buckled and damaged throughout.
- The corrugated siding on the northern section has moderate to severe surface corrosion. It is bent back near the transition between sections and generally in poor condition.

Bent corrugated siding at building transition

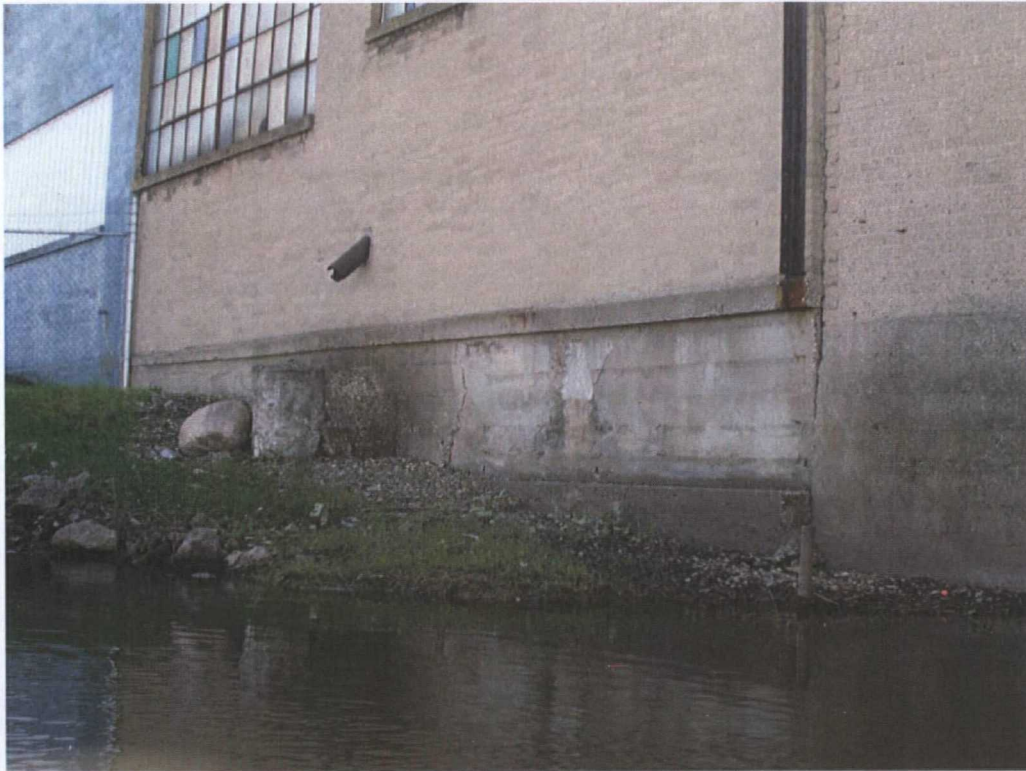
Concrete foundation wall adjacent to the channel

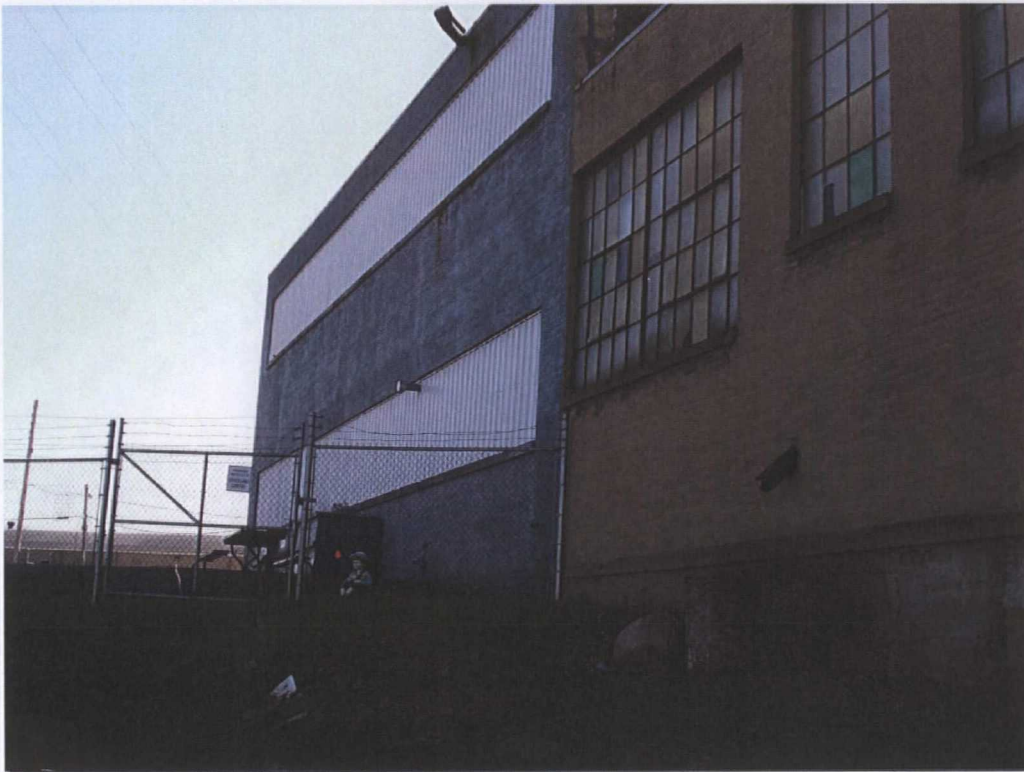
View of structure looking east

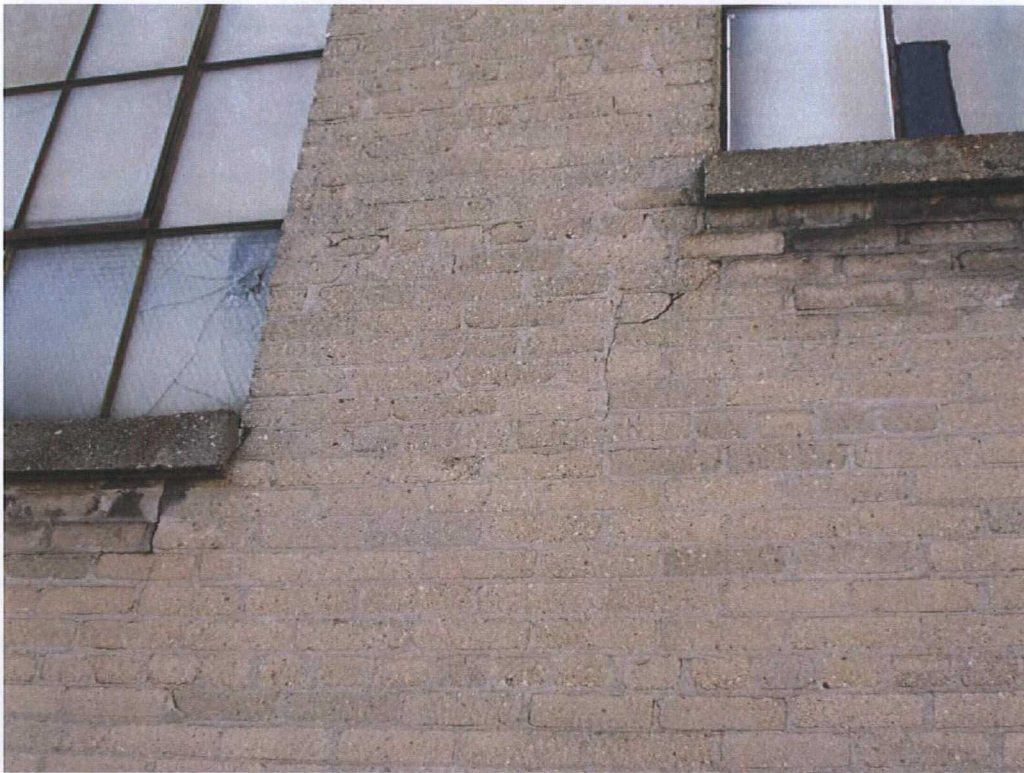
Cracking at window penetration

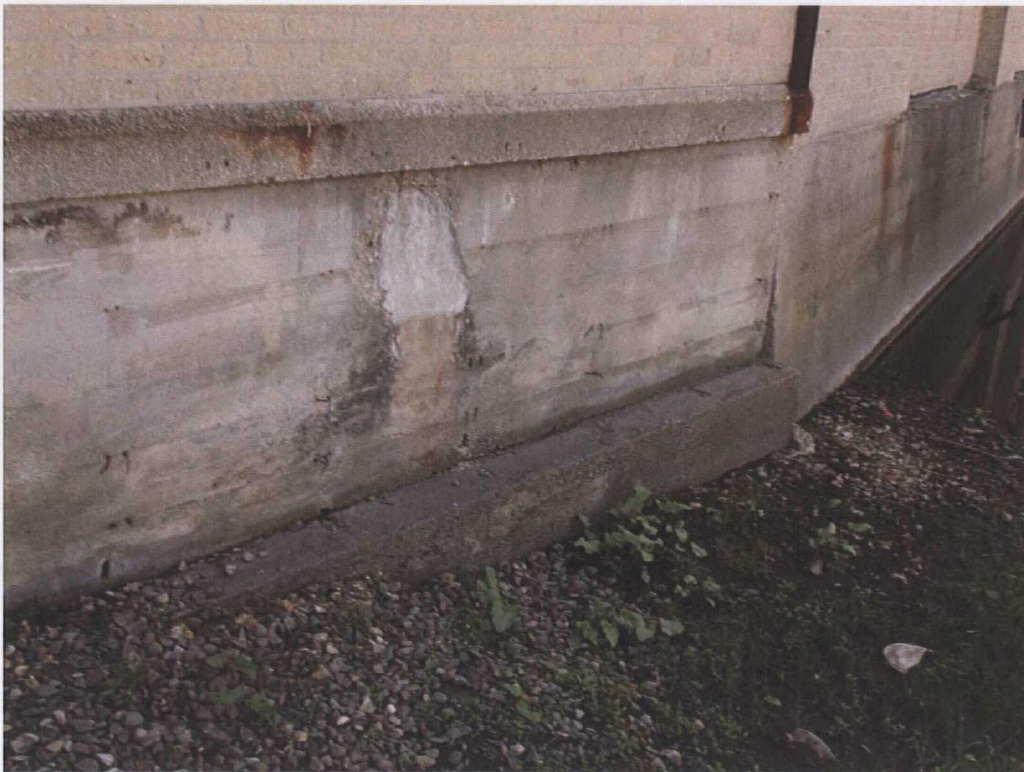
- Minor cracking, severe honeycombing and exposed form ties were noted in the concrete foundation wall.
- The footing is exposed upstream of SA1-C. Minor undermining was noted at the building transition.
- Moderate vertical and step cracking were noted in the brick. Cracking was noted in the primary wall and originating at window penetrations.
- A minor horizontal crack was noted between the concrete foundation and brick near the building transition.
- The eastern section of the building has sealed diagonal/step cracking near the fence line.
- Consumers Energy mapping shows a 2" gas crossing Portage Creek, however it appears to be west of SA1-C-S01 and outside the cofferdam limits.
- City of Kalamazoo mapping shows a water main crossing Portage Creek, however it appears to be west of SA1-C-S01 and outside the cofferdam limits.

Exposed footing near building transition

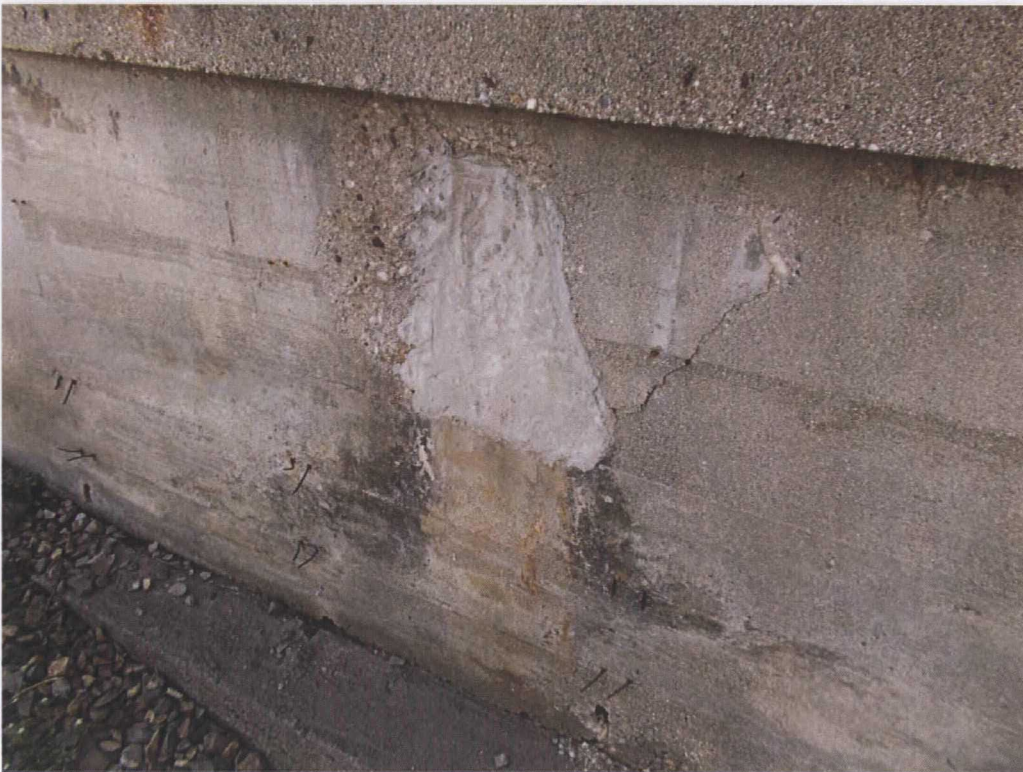
Cracking and patched spalling on face of foundation wall

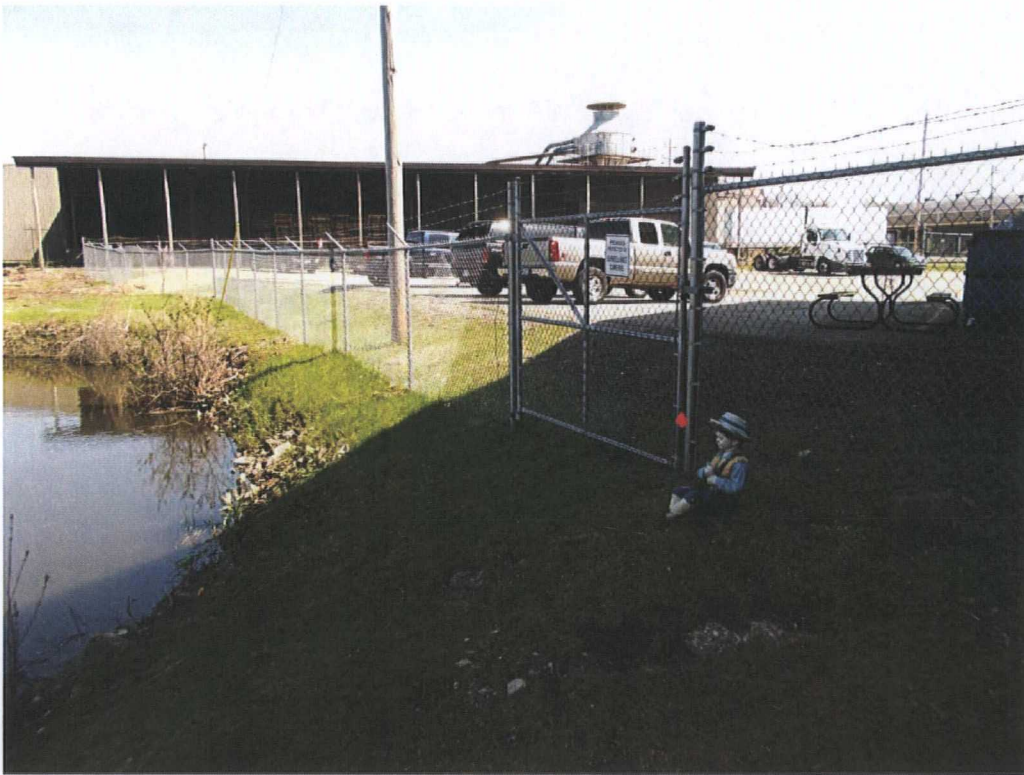
View of fence looking north

- If the fencing conflicts with sediment removal operations, it should be removed and replaced in kind.

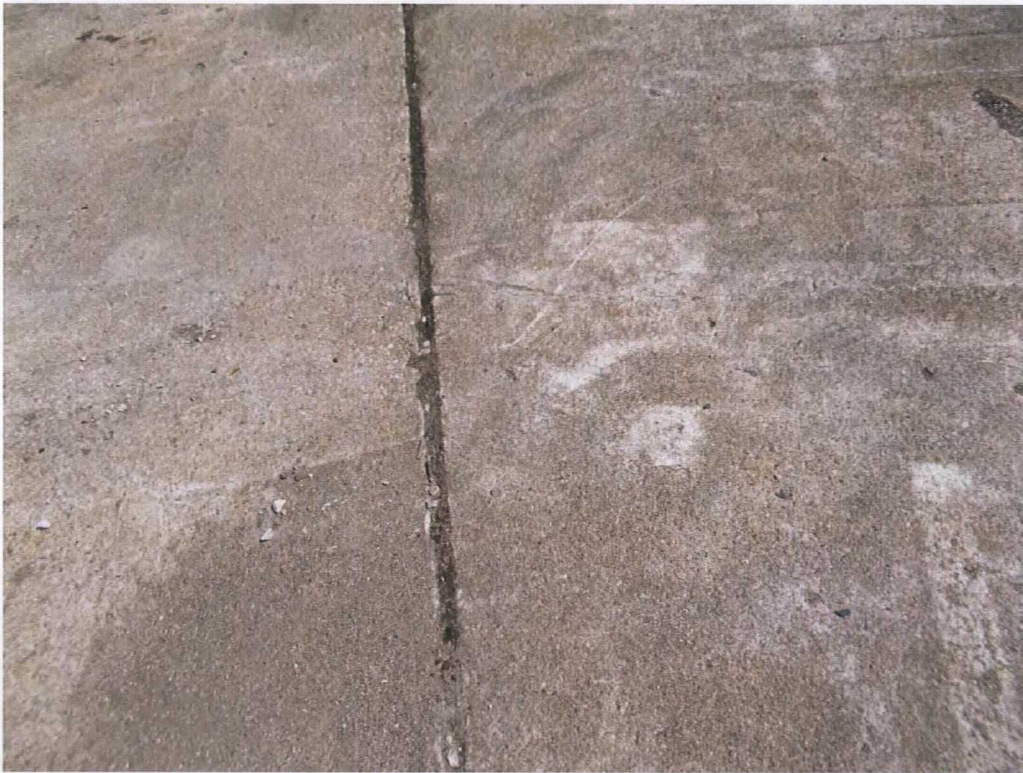
Cracking in surface of pavement

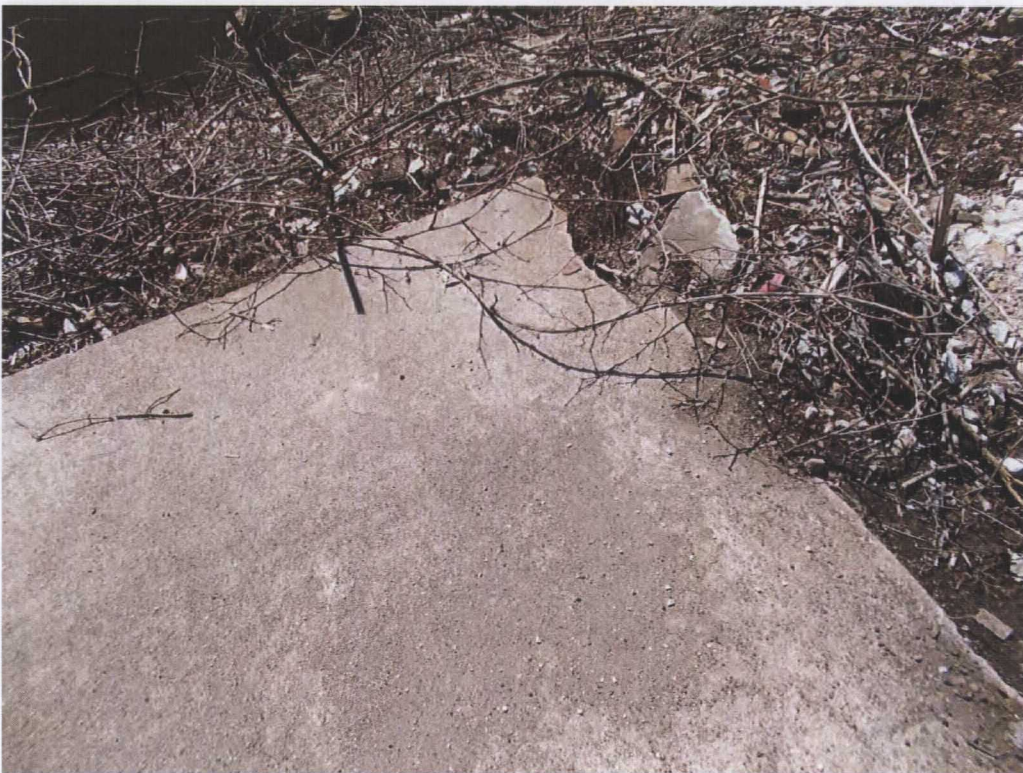
Minor spalling on corner of pavement
